Lesson Learned

Moisture Intrusion in Hermetically Sealed Metering Current Transformers

Source of Lesson Learned: SERC Reliability Corporation

Lesson Learned #: 20191201

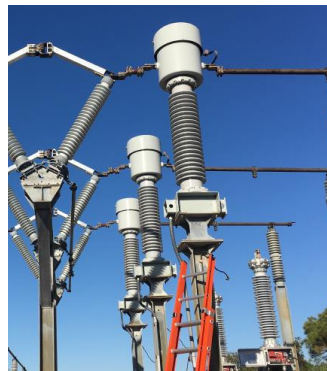
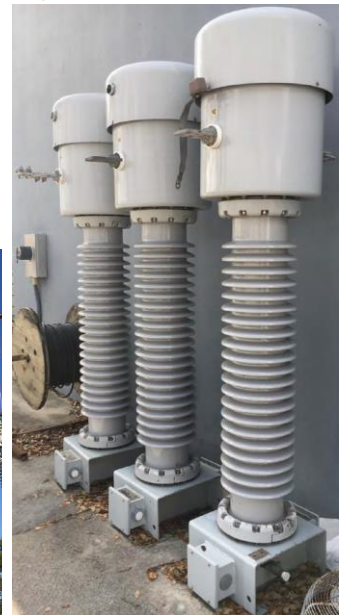
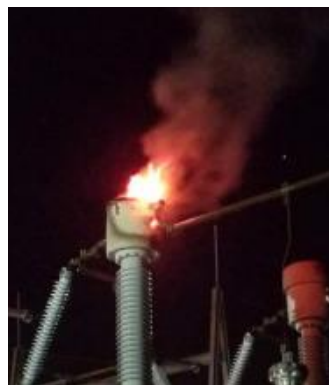
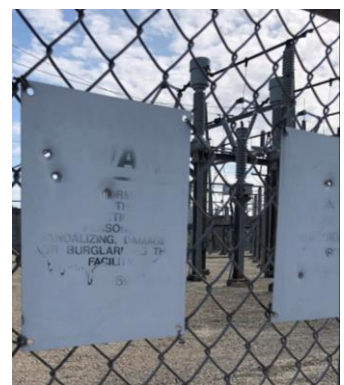
Approximately five weeks later, the C-phase metering CT experienced a catastrophic failure. The fault interrupted transmission service to the utility's entire service territory. Due to discovery of bullet holes in fence signs and visual observations of potential impact markings on an overhead bus bar, it seemed that foul play could be involved at first. In the overnight hours, crews removed and by-passed the faulted C-phase CT and returned the feeder to service.

Post event, the failed C-phase CT was shipped to an independent test lab for forensic analysis. The two

Analysis of relay data post failure shows no indication of problems prior to the failure. The utility has procured and received replacement metering devices. Oil samples have been taken from both the faulted A-phase and unfaulted B-phase CTs for analysis. The initial inspection of the unfaulted B-phase CT did not revealed any abnormalities in oil level, condition, moisture content, or any other visual causes for concern; however, diagnostic test results from those samples indicated elevated moisture content just above acceptable levels for an in-service component. The A and B CTs were sent to an independent test lab for analysis. The final report from the test lab determined the root cause was that the design allowed moisture to enter the metering CT. The seal design allowed moisture at the rim of the two sections of the tank to be pulled in by internal pressure changes in the otherwise hermetically sealed oil containment caused by the daily cycling of temperature (this is more of an effect in de-energized equipment in open storage – not as much in devices heated by being continuously energized). Over time, this allowed atmospheric moisture to contaminate the CT's kraft paper insulation.

After all three single-phase units were removed from service and bypassed to restore service to the single 138 kV feeder to the utility, Engineering ordered new CT/PT combination units. The newly purchased units were also hermetically sealed; however, the design called for a bolted gasket system. In addition,

the utility has implemented a new program that involves the purchase of spare units at the time of initial purchase and to store the spares in a climate-controlled dry, indoor environment.

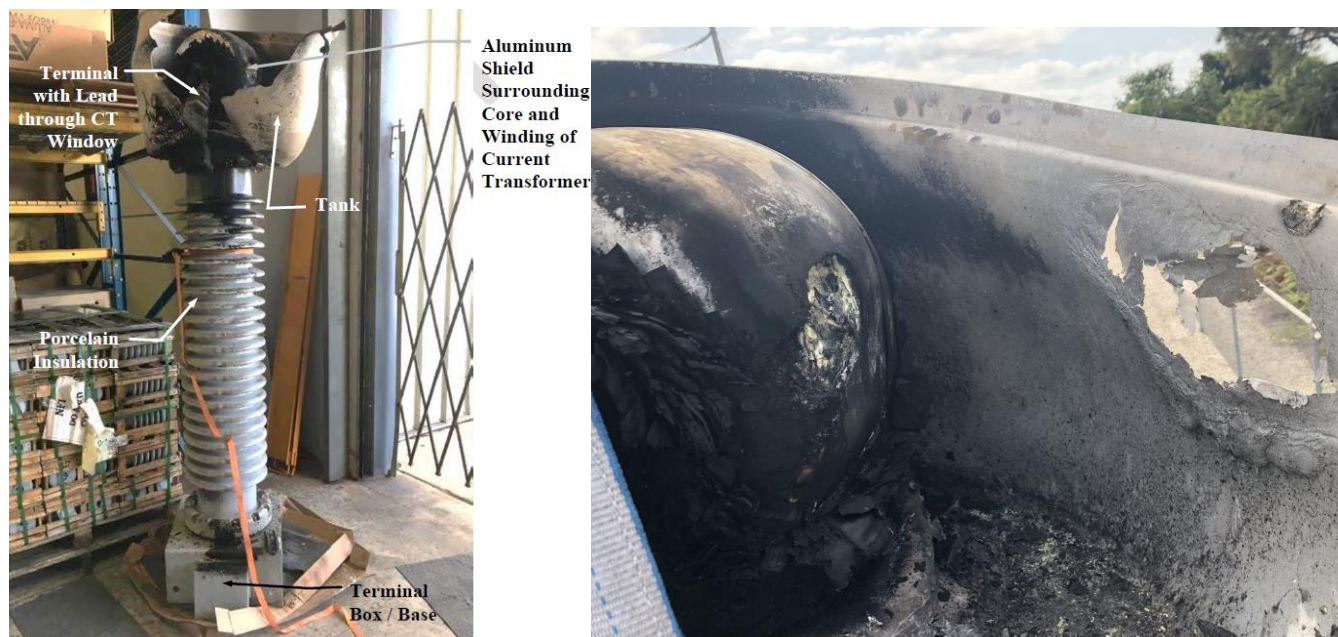
Ten weeks later, the utility experienced a failure of the A-phase CT while awaiting the results of the forensic analysis. The fault interrupted transmission service to the entire service territory once more. Line crews and engineering responded to the station and removed and by-passed both the faulted A-phase CT and the un-faulted B-phase CT for precautionary reasons.
