Lesson Learned

Cascading Analysis Identifies Need for Pre-Contingent Load Shed

20181203

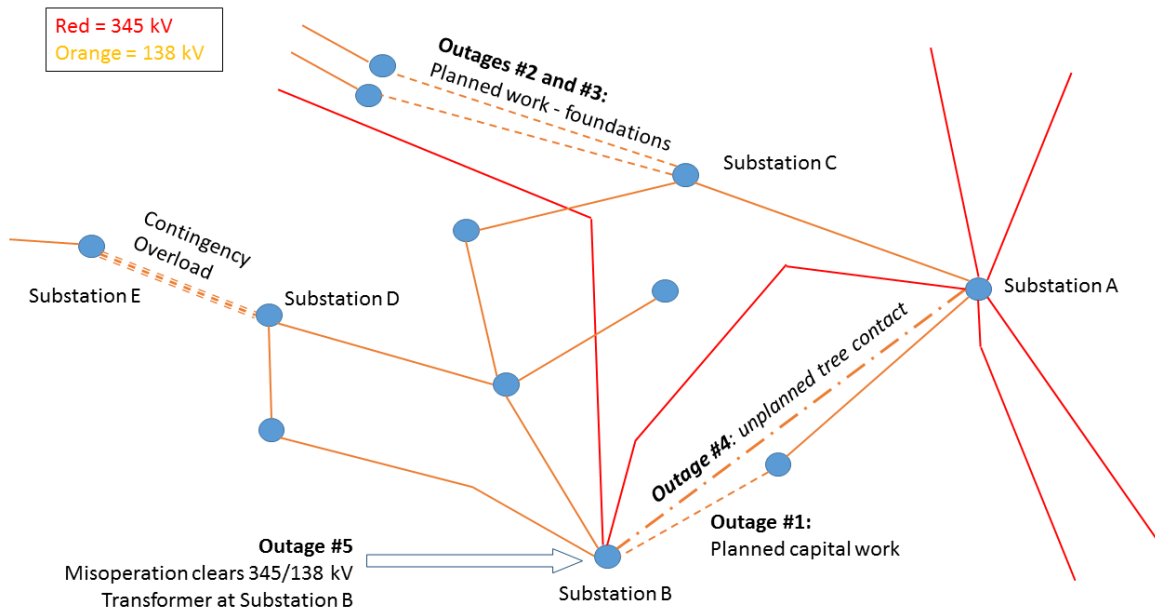
Figure 1: Reference Map

Prior to the event, there were three planned outages in the area (see Figure 1: Reference Map). Outage #1 was in-place for over a month as part of a capital project to reinforce the area. Outages #2 and #3 occurred the morning of the event. Earlier, the RC issued a hot weather alert due to increased temperatures that day. Under those circumstances, TOPs consider deferring noncritical transmission work on the system. In this case, the RC and TOP ran the next day studies to assess the risk and determined that they were N-1 secure. There were no single contingencies that could cause a thermal, voltage, or stability issue on the system. Furthermore, Outages #2 and #3 were both considered recoverable within a few hours (if needed) as the work was to pour foundations under the lines.

Shortly after Noon, a 138 kV line tripped due to a tree contact (Outage #4). Simultaneously there was a misoperation (Outage #5) that tripped the 345/138 kV transformer at Substation B. Following the tree contact and the misoperation, there were no base case violations; however, there were two contingencies identified:

- 140% of emergency rating on the 138 kV line from Substation D to Substation E for the loss of the 345/138 kV transformer at Substation A
- 132% of emergency rating on the 138 kV line from Substation D to Substation E for the loss of the 138 kV line from Substation A to Substation C

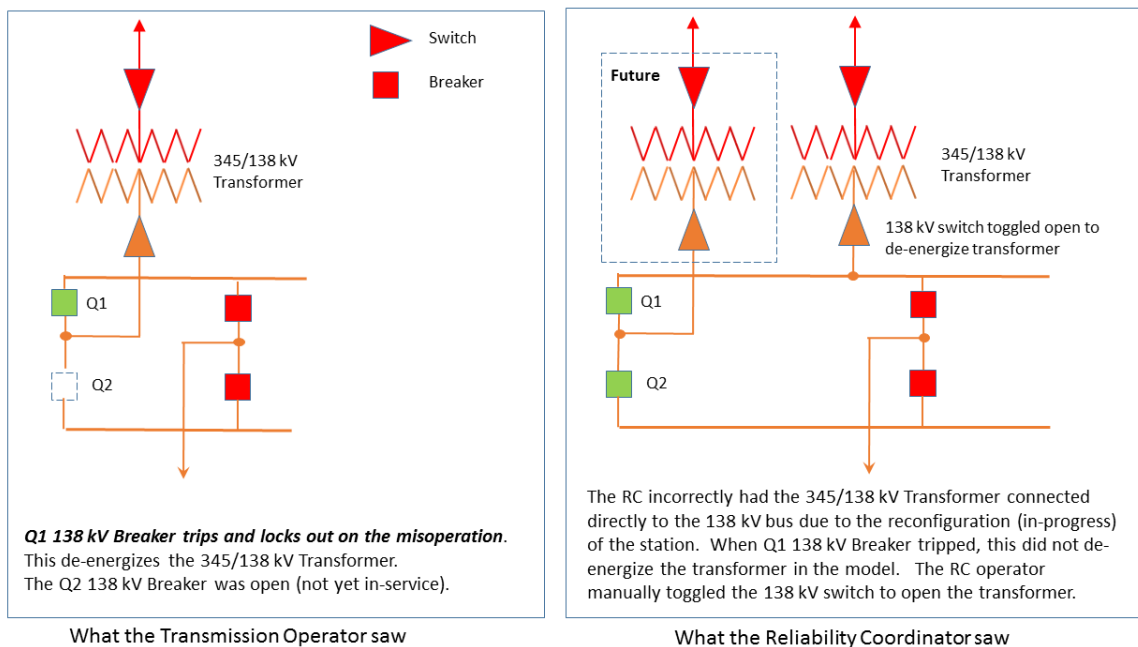
Figure 2: TOP View vs. RC View

At first, the TOP and RC did not agree on the contingency results (see Figure 2: TOP View vs. RC View). Because there was a capital project (in-progress) to reconfigure Substation B, the energy management system (EMS) models were not consistent. The TOP and RC operators quickly resolved the issue over the phone as the TOP explained that the misoperation tripped the 345/138kV transformer. The RC operator manually toggled the 138 kV transformer disconnect switch open in the model, and then they agreed on the contingency results.

- Identify additional controls to help ensure that the TOP's and RC's EMS models accurately align, especially during multi-phased reconfiguration and construction projects. Often the TOP can update its EMS model more frequently than the RC can update its model, so communication is important to notify the RC of the status of the work.
