Lesson Learned

Distributed Energy Resource Performance Characteristics during a Disturbance

Lesson Learned #: 20220401

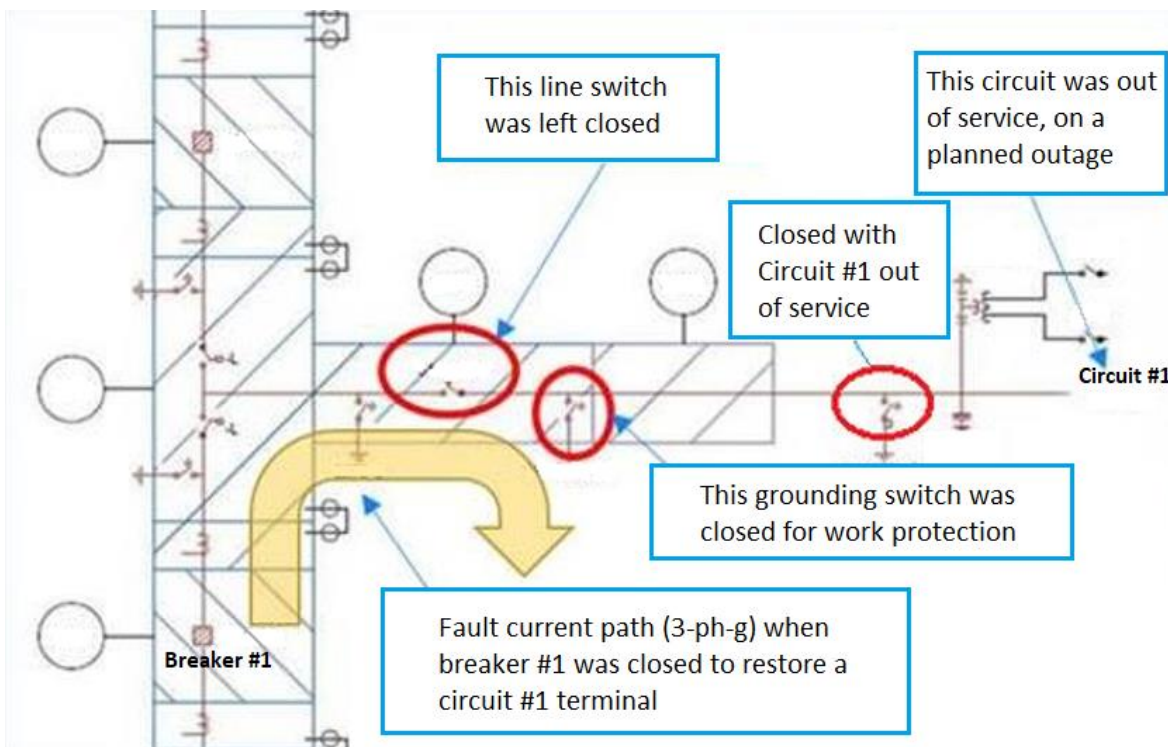
During the restoration of a circuit terminal to service from a planned outage at a 500 kV transformer station, the line was inadvertently energized while still grounded. This resulted in a permanent three-phase-to-ground fault (see [Figure 1](#)).

Figure 1: Diagram of switches involved in setting up the fault
