# Lesson Learned

## IBR Control Interactions and Oscillatory Events

Lesson Learned #: LL20250901  
Date Published: September 16, 2025  
Category: Generation Facilities

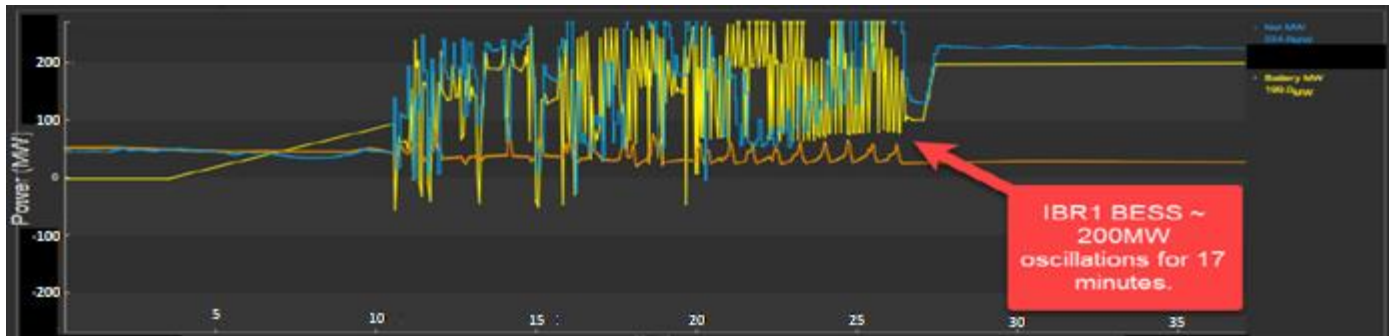
**Figure 1: The First of Three Oscillatory Controller Responses**

The battery began in an idle state when the site controller received a +200 MW discharge setpoint from the utility. The site then began to ramp but started oscillating prior to reaching the +200 MW discharge setpoint.

The oscillations lasted 17 minutes with maximum swings from +275 MW discharging to -138 charging. When the utility contacted the site operator, the site controller was placed in local mode by the site operator with a +200 MW discharge setpoint (as requested by the utility). That mode change resulted in the oscillations being arrested.

Prior to the BESS+PV site commissioning, metering algorithms were developed for point of interconnection (POI) compensation to calculate for transformer losses for solar production when solar energy was passing through the transformer even when solar energy was used for charging the BESS. This algorithm was approved by the operator and the utility and was tested by the operator with passing results. The initial commissioning tests did not uncover an issue with invalid data related to a divide-by-zero condition. The oscillations were the result of implausible MW compensation values calculated by the site metering algorithms. An evaluation indicated that the compensation algorithm encountered invalid data referred to as NaN (not a number, or invalid number, resulting typically from dividing by zero). The use of this data created an error that increased the compensated MW values beyond the actual MW capacity of the site.

Four days after the event, the loss compensation logic was disabled in the meters for the solar charging BESS conditions and new loss compensation logic was written to eliminate the divide-by-zero scenario; this logic has been approved by the utility and implemented on the site controller.

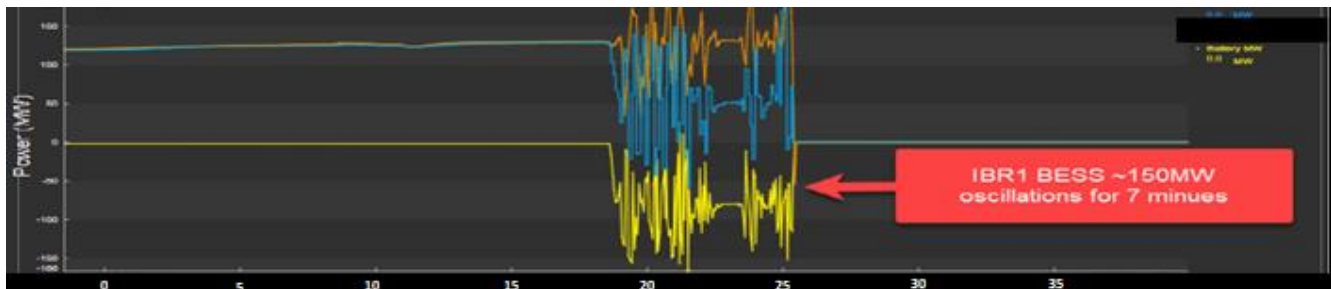
**Figure 2: The Second of Three Events**

The second event (see [Figure 2](#)) began with an initial state of the battery dispatched from a 0 MW setpoint to 80 MW charge at ~11:53 Eastern. The battery ramped to -80 MW (charging) and then began oscillating, with maximum indicated “output” of ~8 MW and minimum of -160 MW. The adjacent PV site was under commissioning and was injecting power to the grid during the event. The site controllers had a control system update pushed the day prior to the event. To perform this update, the programmable logic controller (PLC) was restarted, and all inverters were taken off-line and restarted, which was NOT standard practice for a controller update. Typically, the inverters would remain on-line during the update in standby mode. After restarting, some of the inverters came back on a mode where they were not on-line unless a MW dispatch signal was being received. This resulted in a delay in the response of the inverters at the site. The oscillatory behavior was not consistent between the three-site generator step-up transformers (GSU) as GSUs 1 and 2 showed similar behavior and GSU 3 had more aggressive output swings indicating that the problem was not sourced with the site controller but with the translation of the controller commands to the three GSUs.

The GSU MVA protection logic was updated to prevent the MVA remaining value from going negative as well as the mismatch in GSU command interpretation logic across all three GSUs made consistent across GSUs. The secondary cause of the extended/unbalanced startup of inverters was repaired by ensuring that all inverters start up with a 0 MW command (instead of starting up only with non-zero commands) to avoid the potential for inverter restarts regardless of a PLC controller restart.

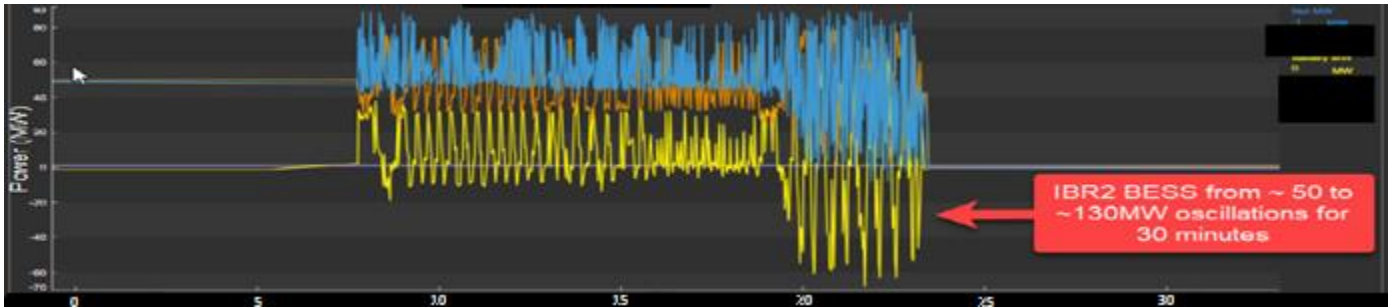
**Figure 3: The Third of Three Events**

The third event (see [Figure 3](#)) began with an initial state of the battery dispatched from a 0 MW setpoint to 37 MW discharge at ~17:25 EST. Site output immediately began oscillating, with maximum output of ~85 MW and minimum output of -40 MW. The adjacent PV site was under commissioning and injecting ~50 MW at the time of event initiation.

The short-term solution was to force the controller feedback to only one source, the BESS-only meter, until more robust dual-meter logic could be developed. The long-term solution is to reincorporate solar into the BESS site MW feedback function, validate that these same countermeasures are applied at all co-located solar/BESS facilities under construction, and update integrator functional design specifications.

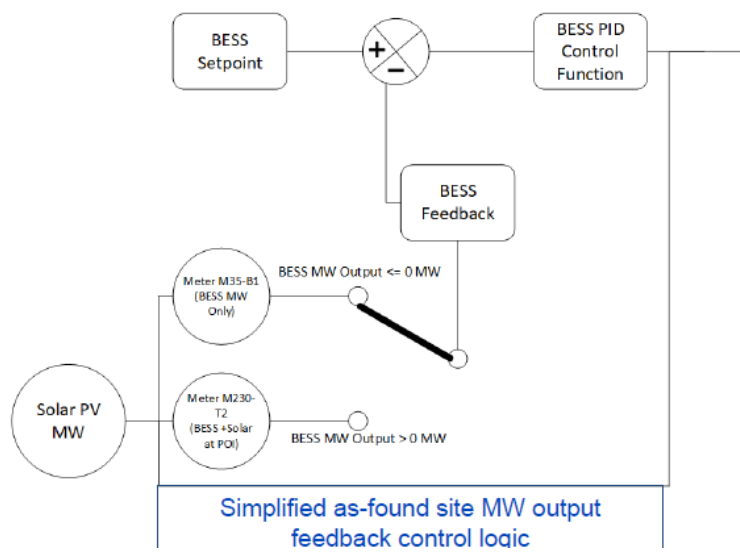
**Figure 4: As-Found PID Controls Scheme**

The battery MW output value that is fed back to the proportional integral derivative (PID) control loop (see [Figure 4](#)) is dependent on the site charging or discharging status. For battery discharging, the logic must include solar power contributions to prevent interconnection limit violations. At the time of the event, an incorrect forced 0 MW solar output was fed into the metering scheme that resulted in the controller interpreting the measured solar power output as BESS output. When the BESS + solar meter source was selected, the controller incorrectly determined that the site was exceeding interconnection limits. But when the battery was commanded to discharge, the controller included the 50 MW of solar power as battery output, which went over the commanded 37 MW output. This caused the controller to reduce output, switching to the battery-only meter once the output dropped below zero. Once the battery output dropped below zero, the controller saw the output as too low based on the commanded 37 MW and swung back to the BESS + solar meter, thus triggering the oscillation.
