# Lesson Learned

## BESS Output Oscillation Due to OEM Software Update

Lesson Learned #: LL20260918  
 Date Published: September 18, 2026  
 Category: Communications

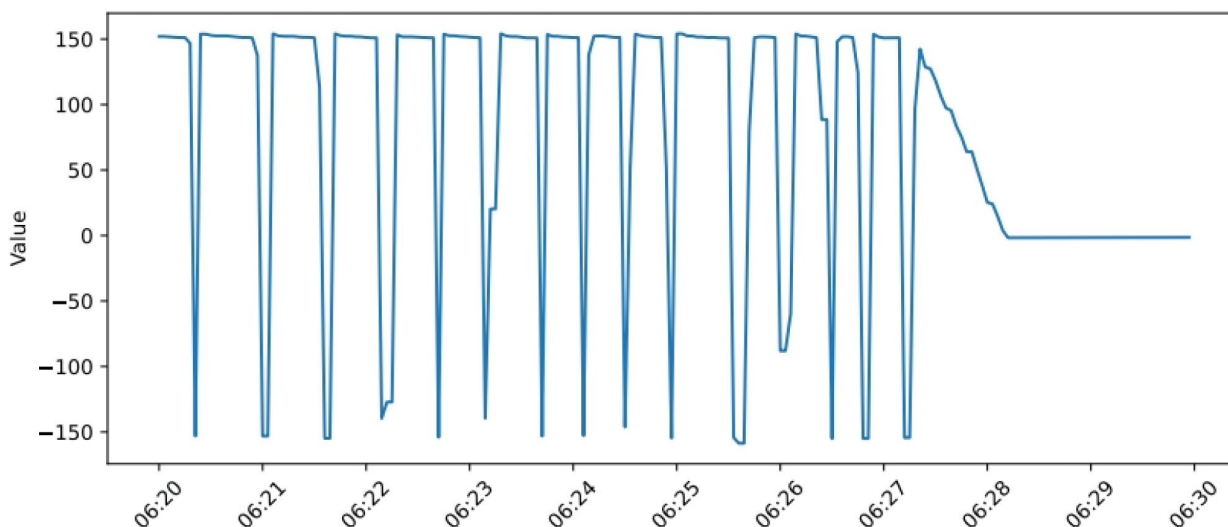
**Figure 1: Oscillations from BESS Facility**

A battery energy storage system (BESS) was subject to an original equipment manufacturer (OEM) software modification to the energy station controllers (ESC) to implement a new control feature. This modification was intended to be run in a test environment but was accidentally implemented on site, which resulted in a divide by zero calculation for a MW setpoint, leading to an infinite gain and driving the plant to oscillate between its limits.

Via supervisory control and data acquisition (SCADA), the BA and TOP observed the BESS output oscillating between +/- 150 MW starting at 6:19 a.m. for approximately 11 minutes (see **Figure 1**). The TOP issued an operating instruction for the BESS, directing it to come off-line within 10 minutes due to oscillations and cycling outside of market dispatch. The site operator informed the system operator that the resource would be coming off-line shortly but failed to do so in a timely manner. The system operator directed the BESS operator to cease operations for a second time 9 minutes later. The BESS operator complied and was off-line at 6:30 a.m., approximately 11 minutes after the initial operating instruction was issued. At 06:30 a.m., the resource was removed from the grid until the root cause could be determined and future occurrences prevented.

- The external virtual private network (VPN) connection to the controls vendor was disabled until additional processes are added to ensure that test environment changes are not inadvertently applied.

- The BESS operator reinstalled the prior-version software and performed system testing to validate proper performance.
- The BESS operator implemented preliminary changes in its existing SCADA platform to detect and alarm oscillatory behavior.

- The BESS completed SCADA upgrades to remove division by zero calculations, enhance data granularity, and add oscillatory behavior alarming.
- The BESS provided lesson learned and three-part communication refresher training to site operators to ensure timely adherence to operating instructions.
